Sifter Parts & Service, Inc.

Inspection Porthole for the CS-1 Sifter

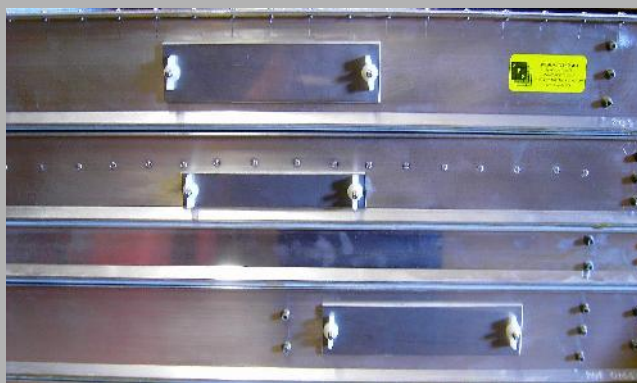
CS-1 inspection portholes with the cover plates & wing nuts installed.

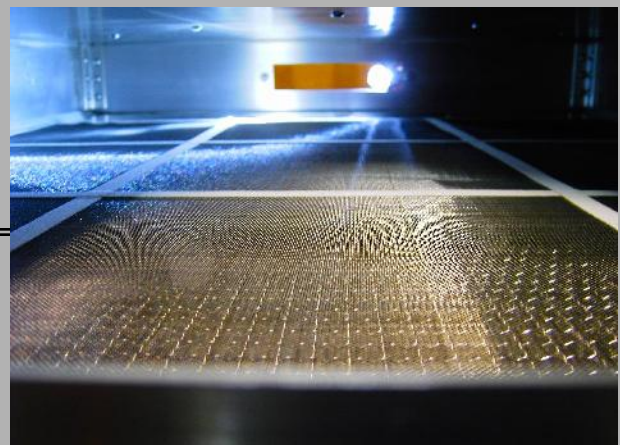
View of the screen through opposing porthole, allowing full view of the screen area.

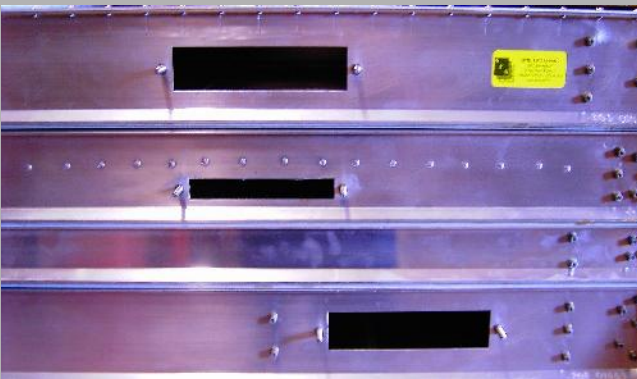
Inspection portholes with the cover plates & wing nuts removed.
